Debris/Ice/TPS Assessment and Integrated Photographic Analysis of Shuttle Mission STS-88

**DEBRIS/ICE/TPS ASSESSMENT
AND
INTEGRATED PHOTOGRAPHIC ANALYSIS
OF
SHUTTLE MISSION STS-88**

4 December 1998

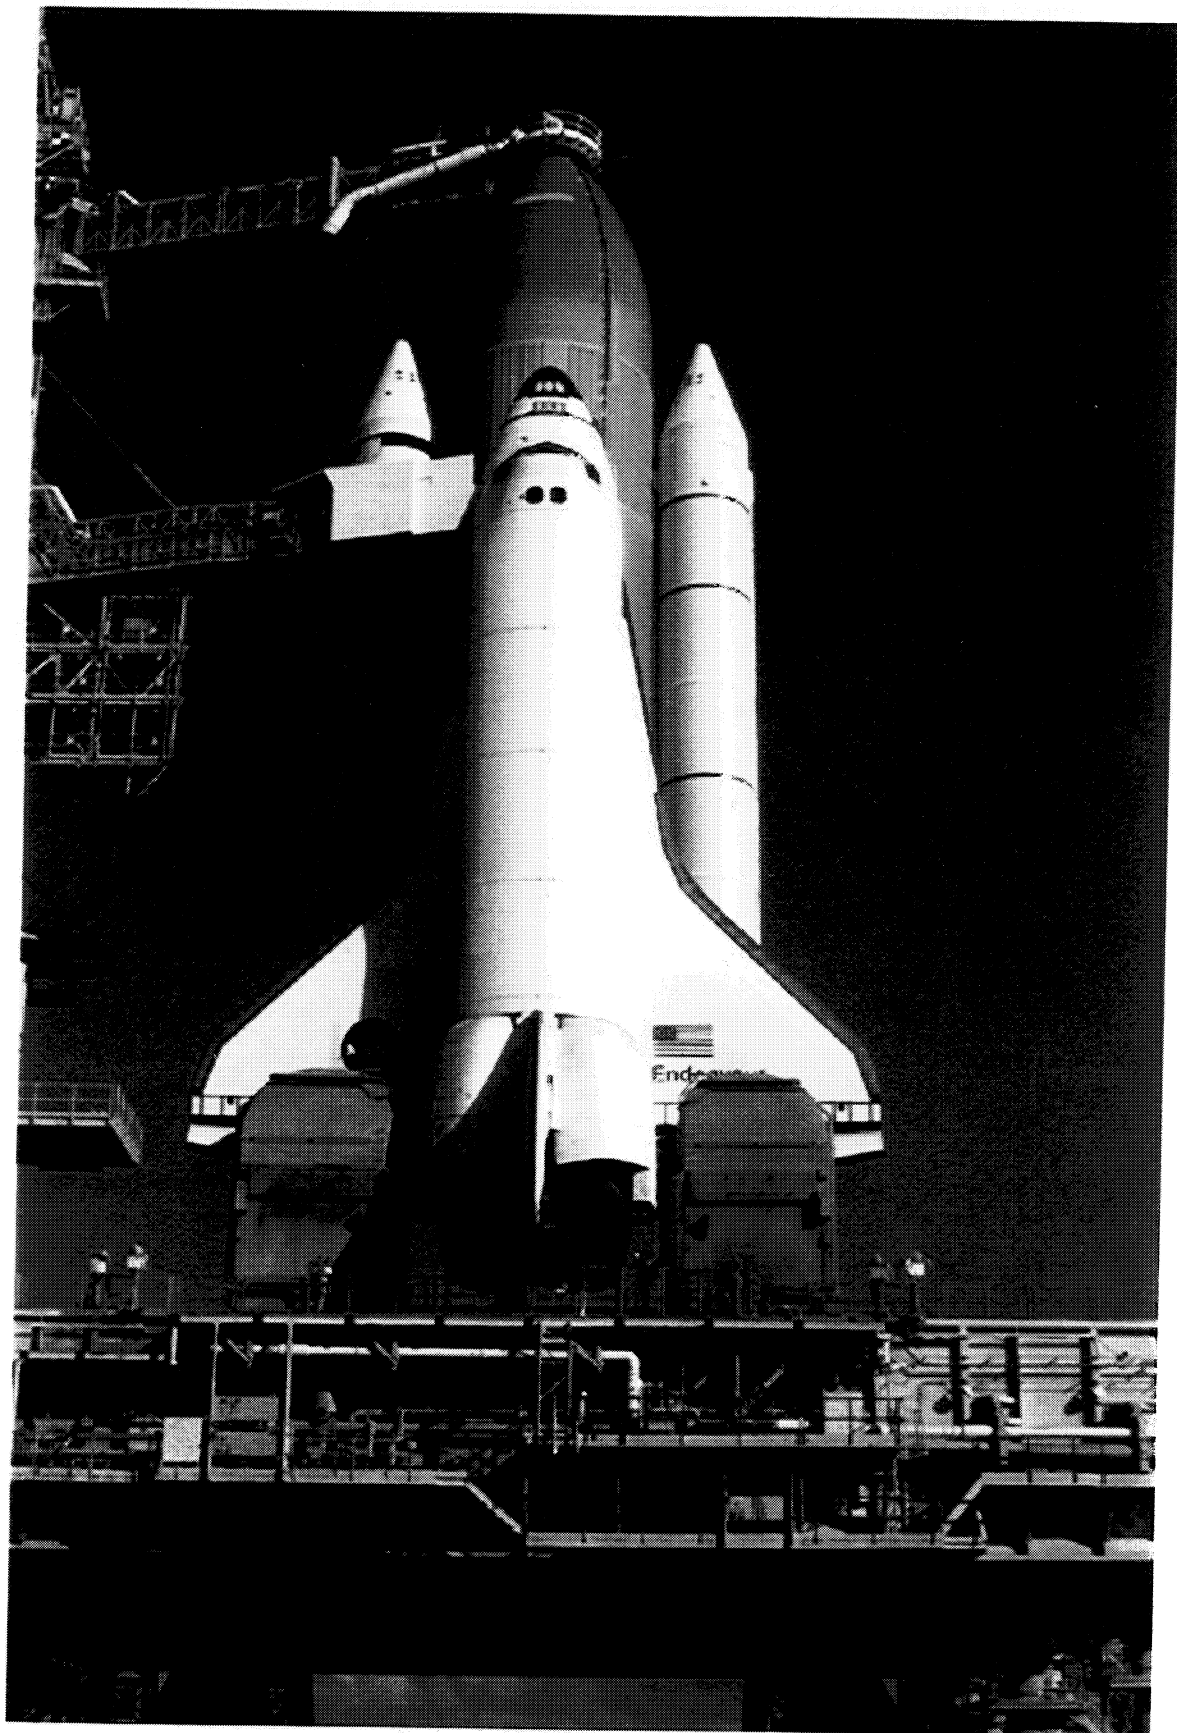
Photo 2: STS-88 Ready for Launch

STS-88 consisting of OV-105 Endeavour (13th flight), ET-97, and BI-095 SRBs on MLP-3/Pad 39A prior to cryoload

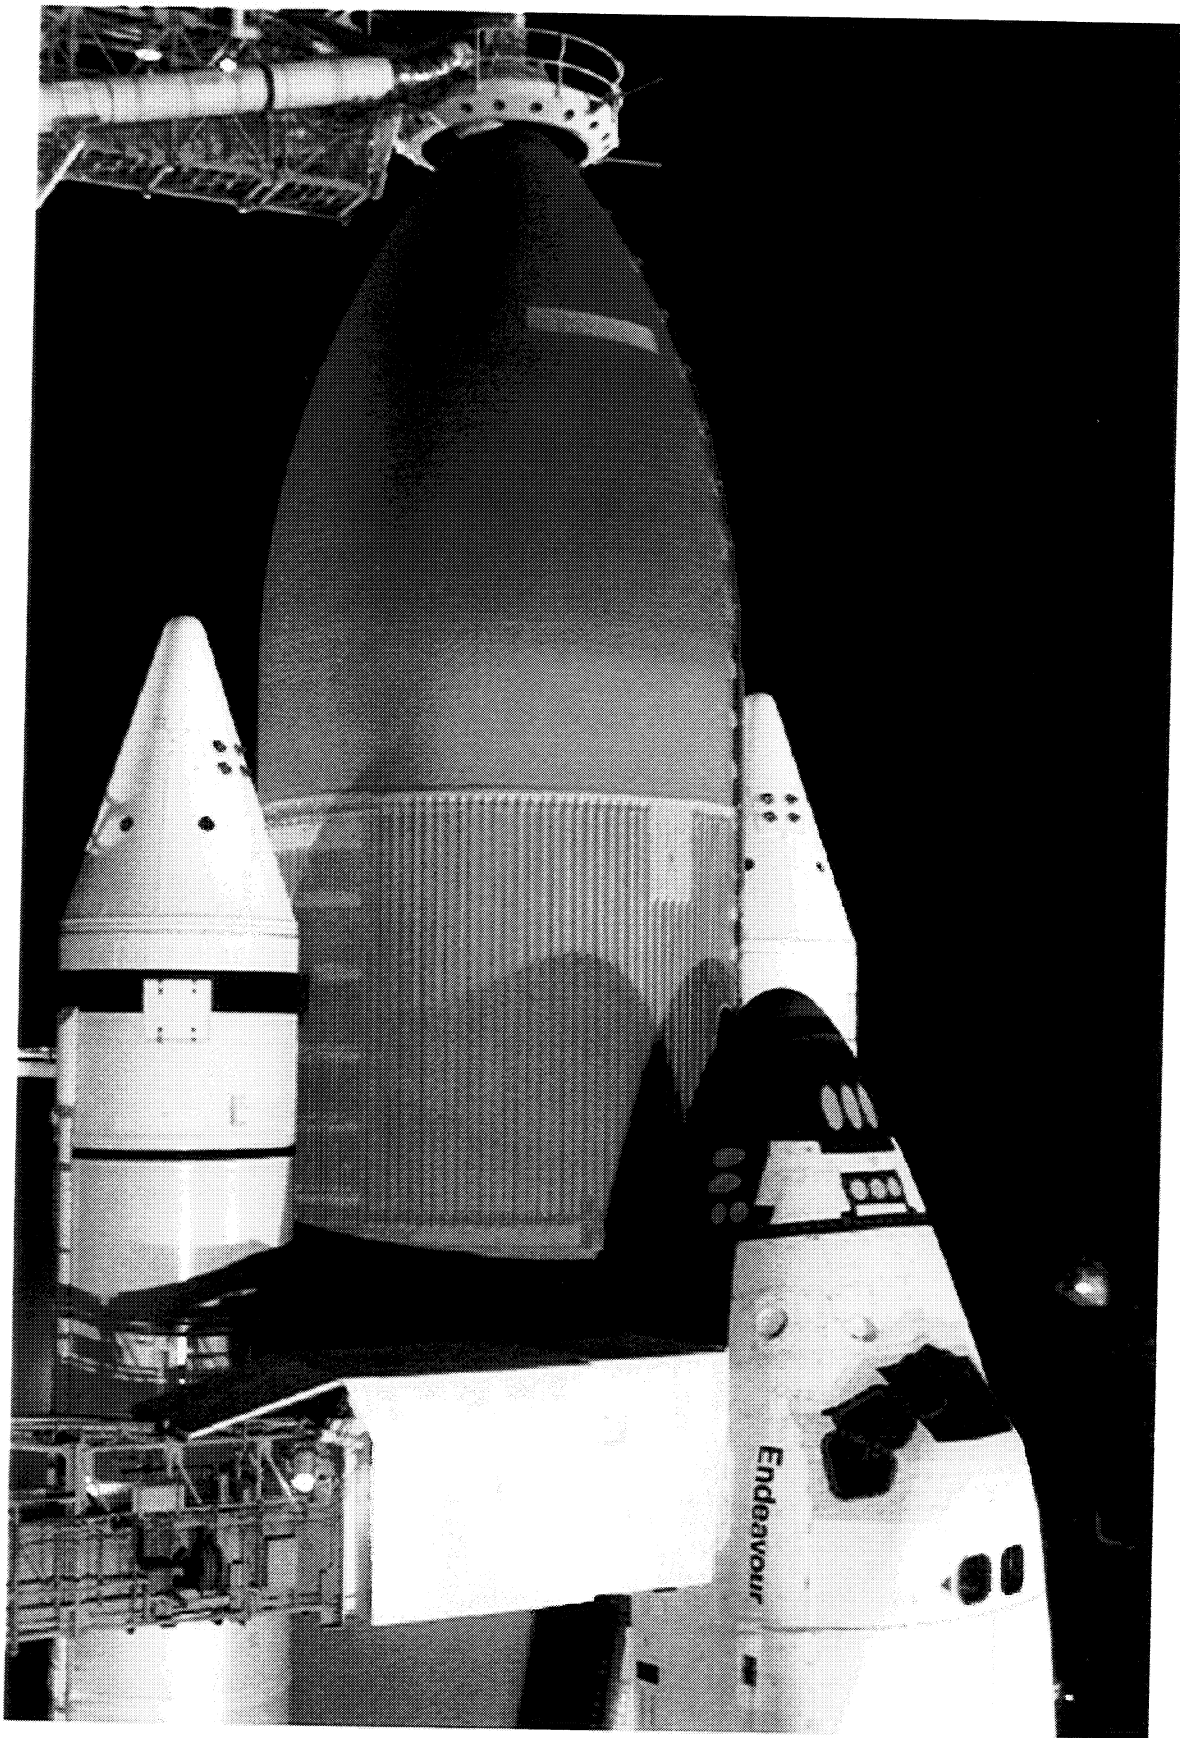
Photo 5: STS-88 Ready for Launch

The Thermal Protection Systems performed nominally during cryoload. The Final Inspection Team observed very light condensate, but no ice or frost accumulations, on the LO2 tank acreage. Surface temperatures averaged 50 degrees Fahrenheit.

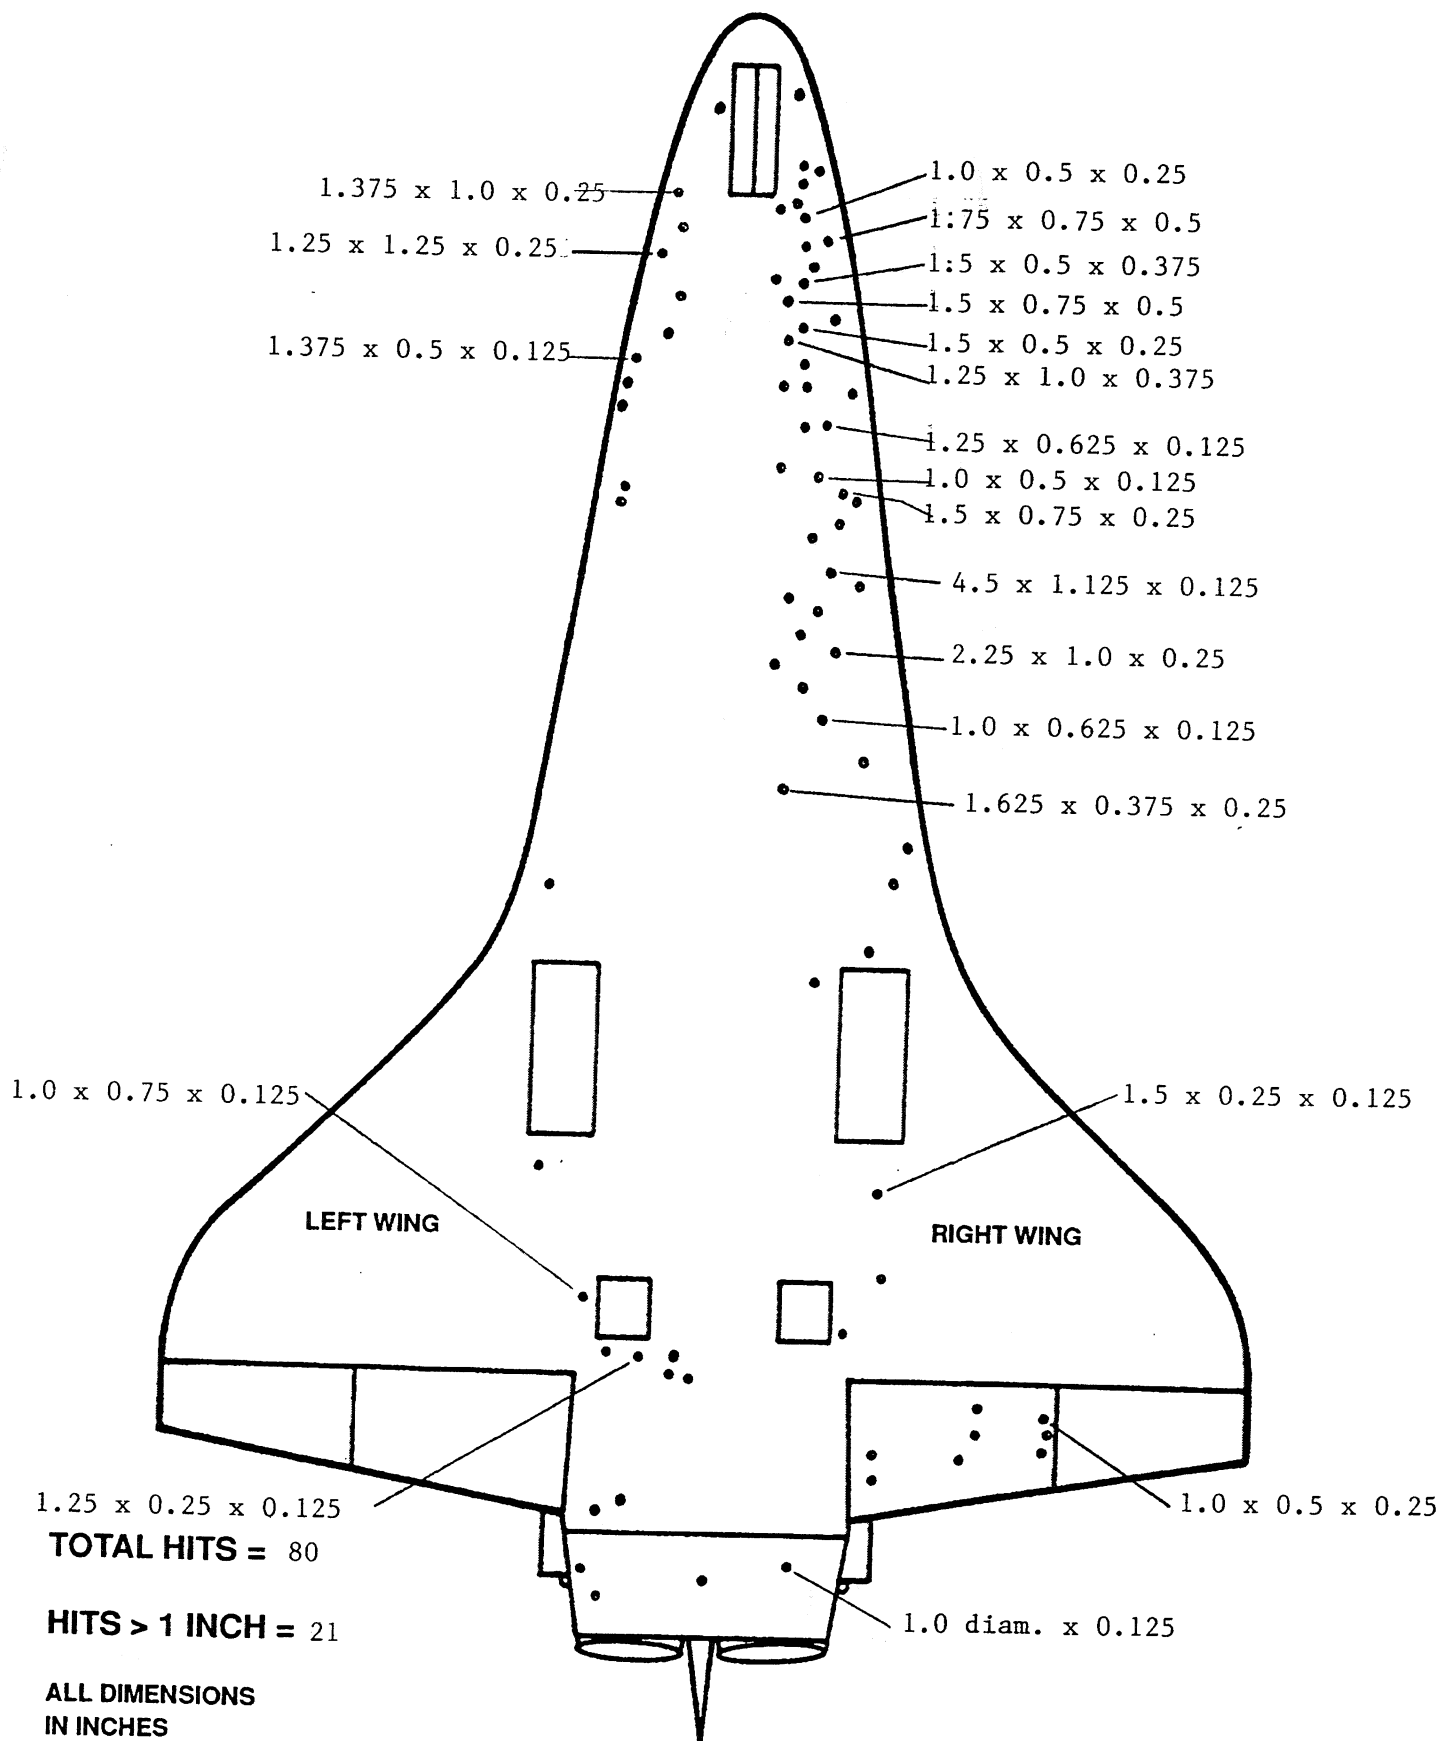
Figure 1: Orbiter Lower Surface Debris Damage Map

The Orbiter lower surface sustained 80 total hits, of which 21 had a major dimension of 1-inch or larger. Most of this damage was concentrated between the nose gear and the main landing gear wheel wells on both left and right chines though the predominant number of damage sites occurred on the right side. (It should be noted there was no unusual or unexpected accumulations of ice in the ET LO2 feedline bellows and support brackets at the time of launch). The outboard damage sites on the chines followed a similar location/damage pattern documented on STS-86, -87, -89, -90, -91, and -95, though the pattern was not as symmetric as the previously noted flights. It should also be noted that this was the third flight of the new Super Light Weight Tank.

No lower surface tiles were scrapped due to debris damage. The largest lower surface tile damage site, located on the right chine, measured 4.5-inches long by 1.125-inches wide by 0.125-inch deep. The deepest lower surface tile damage sites measured 0.5-inches and were located on the right chine.

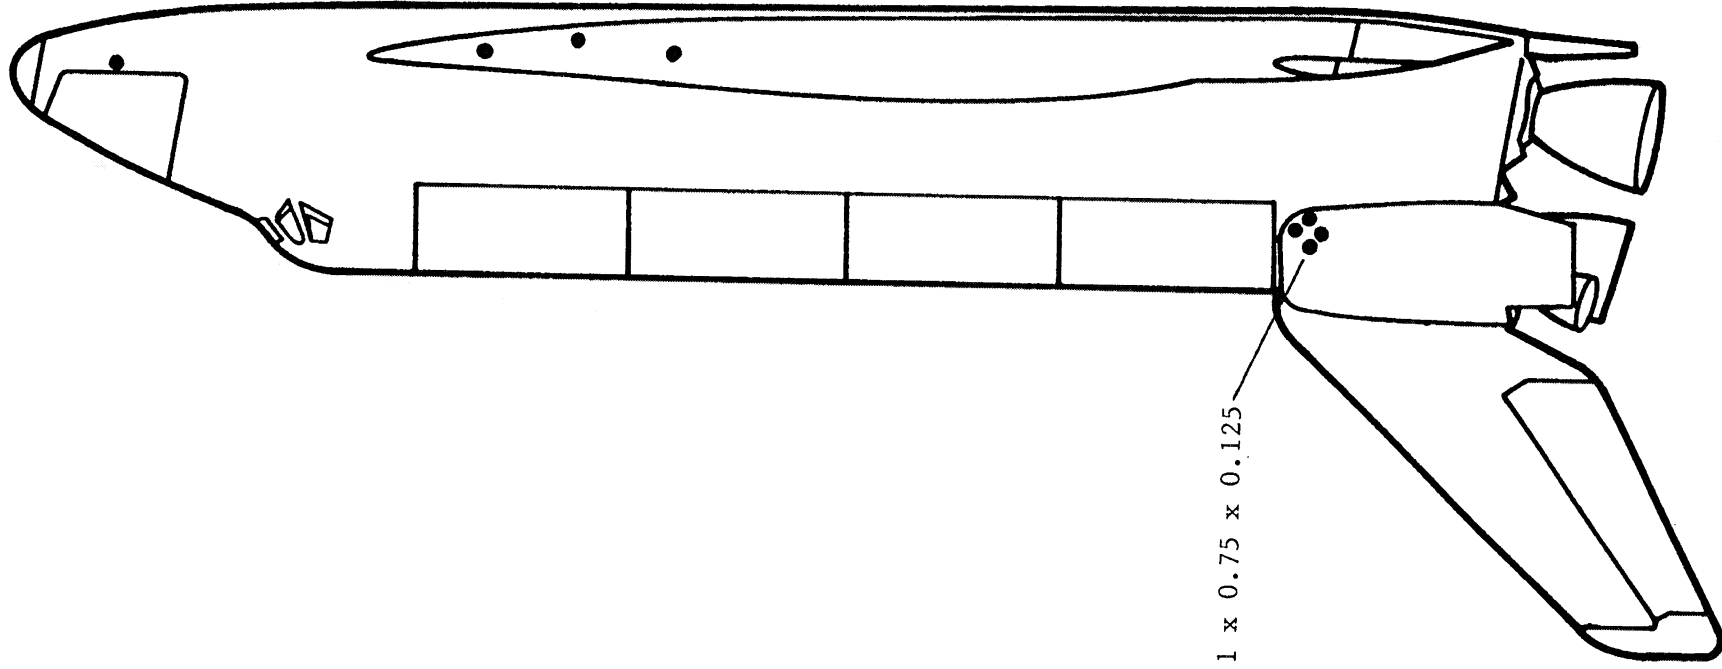
Figure 3: Orbiter Right Side Debris Damage Map

TOTAL HITS = 8
 HITS > 1 INCH = 1

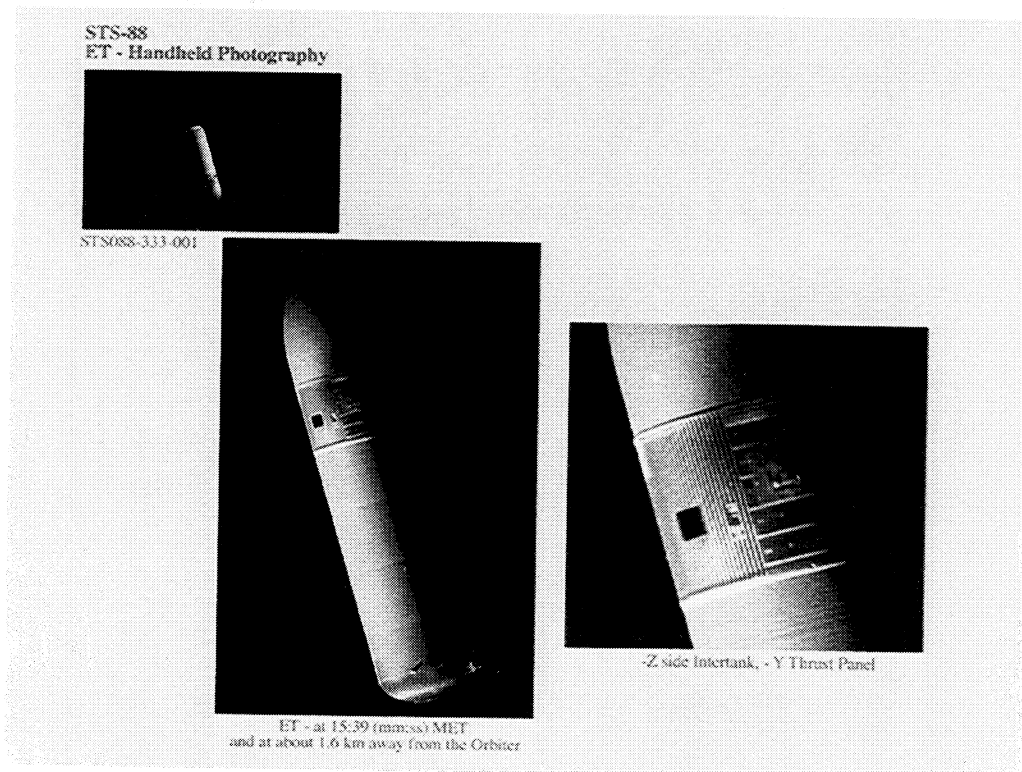
Figure 2.5.3 (A) ET -Y Thrust Panel, ~ 1.6 km Distance from the Orbiter

Ten 35 mm handheld film views of the ET were enhanced to restore the resolution of the imagery for detailed analysis. Two enhancements of the ET intertank region at a distance of approximately 1.6 km and 3 km from the Orbiter are shown in figures 2.5.3 (A) and 2.5.3 (B).

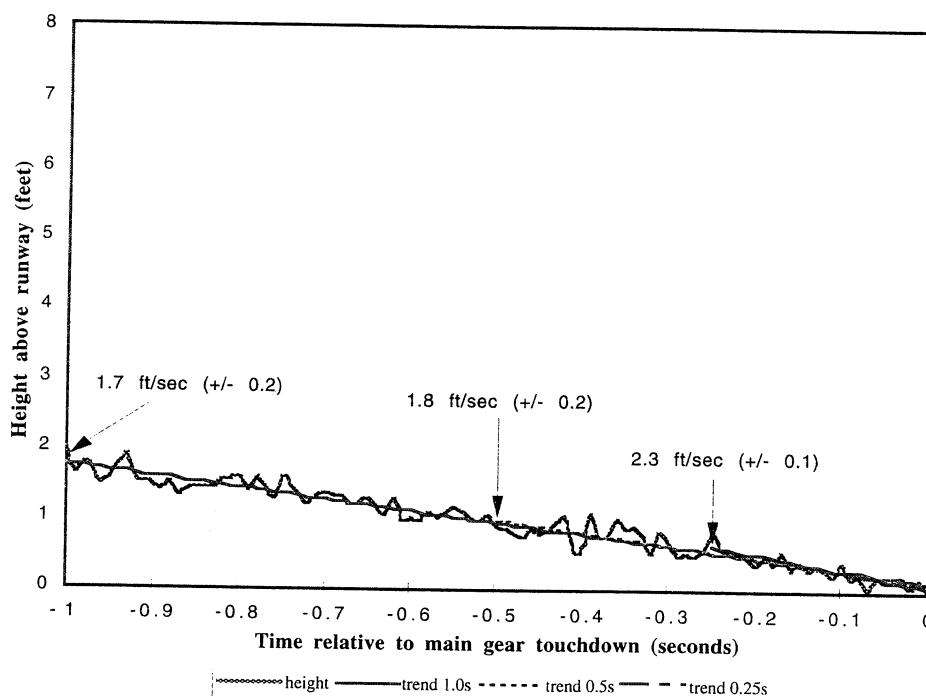
Figure 2.6.1 Main Gear Landing Sink Rate

The maximum allowable main gear sink rate values are 9.6 ft/sec for a 212,000 lb vehicle and 6.0 ft/sec for a 240,000 lb vehicle. The landing weight of the STS-88 vehicle was estimated to be 201,606 lbs.
